# Combination of precise laser and FIB milling for TEM based IC failure analysis

EFUG - Workshop, Bordeaux 28<sup>th</sup> September 2017

Fraunhofer Institute for Microstructure of Materials and  
Systems, Center for Applied Microstructure Diagnostics (CAM)

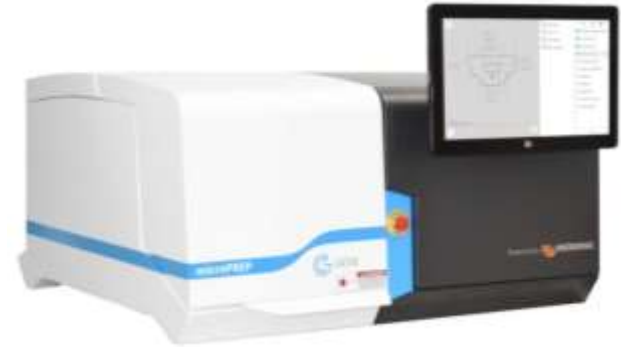
Technical specifications:	
Laser source	DPSS Picosecond Laser Wavelength: 532 nm Max. Power: 3 W
Camera system	FOV: 3.2 x 2.3 mm <sup>2</sup> Resolution: 2.2 μm
Motion system	<u>Rotary axis</u> Stroke: ± 50° Accuracy: < 0,03° <u>Z-Axis</u> Stroke: 1 cm Accuracy: 5 μm
Laser processing	Up to 25mm large structures in <30min Accuracy ± 3 μm

Damage layer <100nm for Si

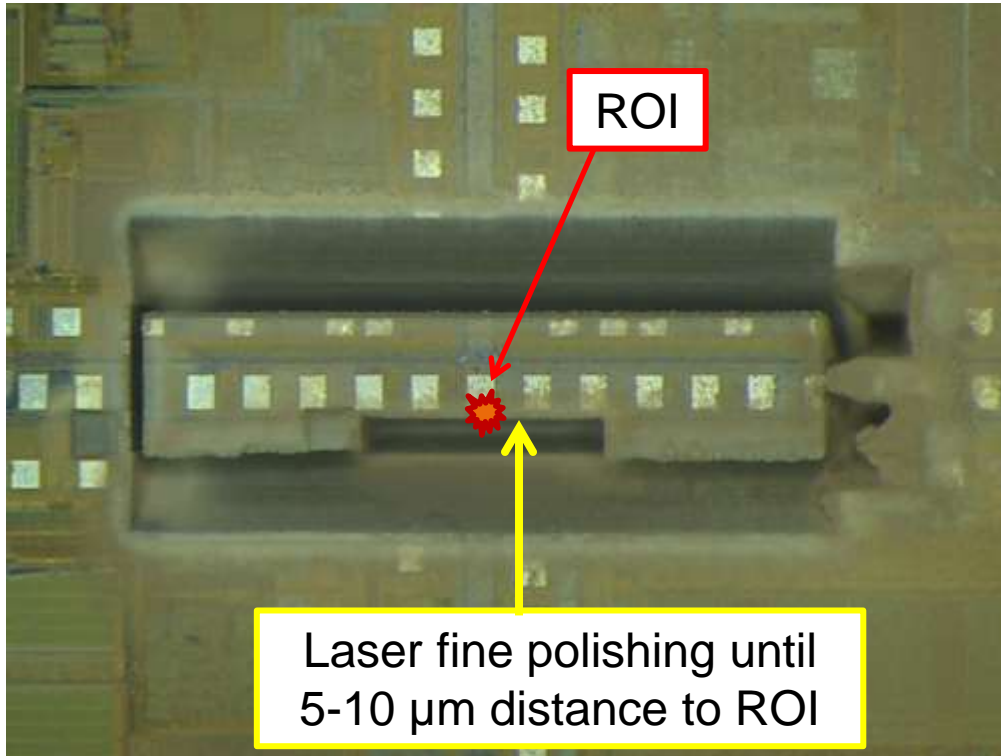
- XL Chunk™ recipe to isolate ROI from rest of IC
- Size of IC bar relative to Cu-ring size :  $2000 \times 400 \mu\text{m}$
- Laser fine polishing to ROI with **5-10  $\mu\text{m}$  distance**
- Short laser preparation time: ~ **6-10min**

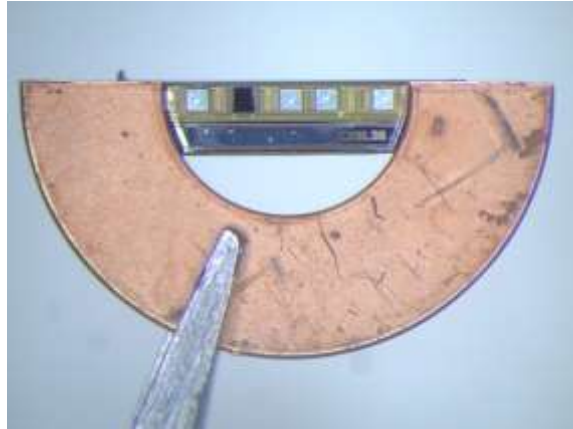
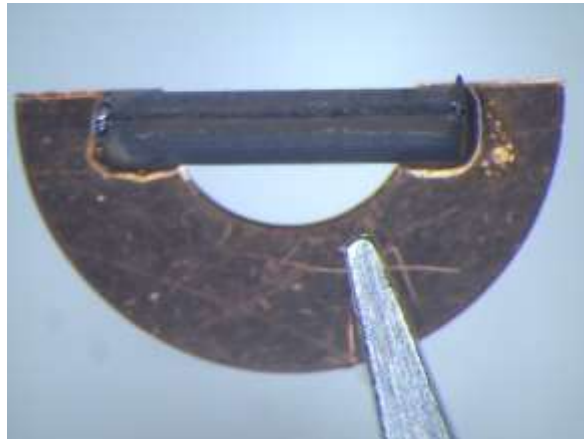
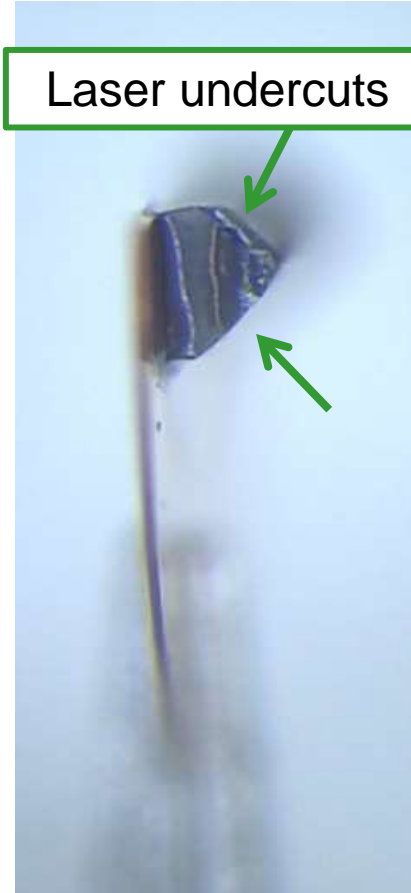
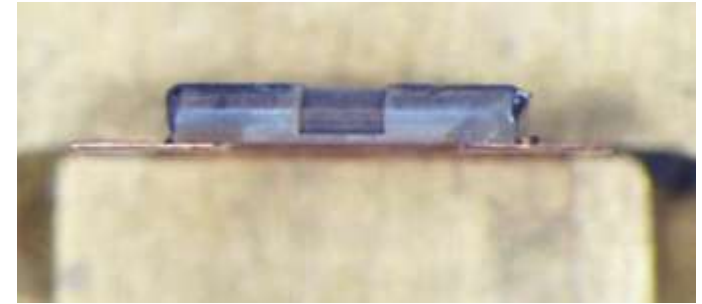
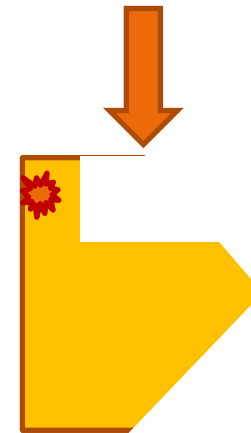
Glued chunk

Additional local laser thinning of substrate to reduce FIB preparation time

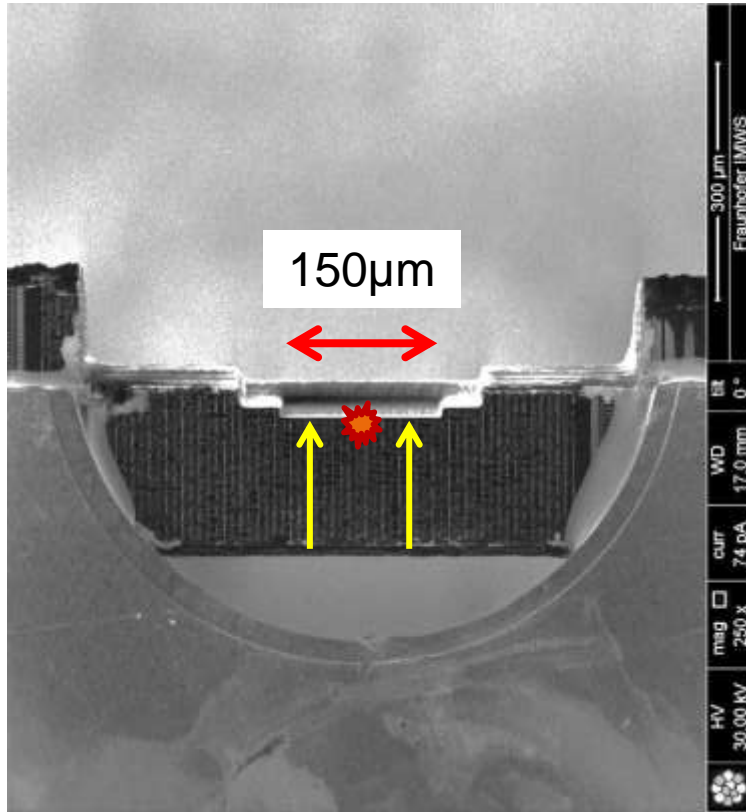
PFIB milling close to ROI

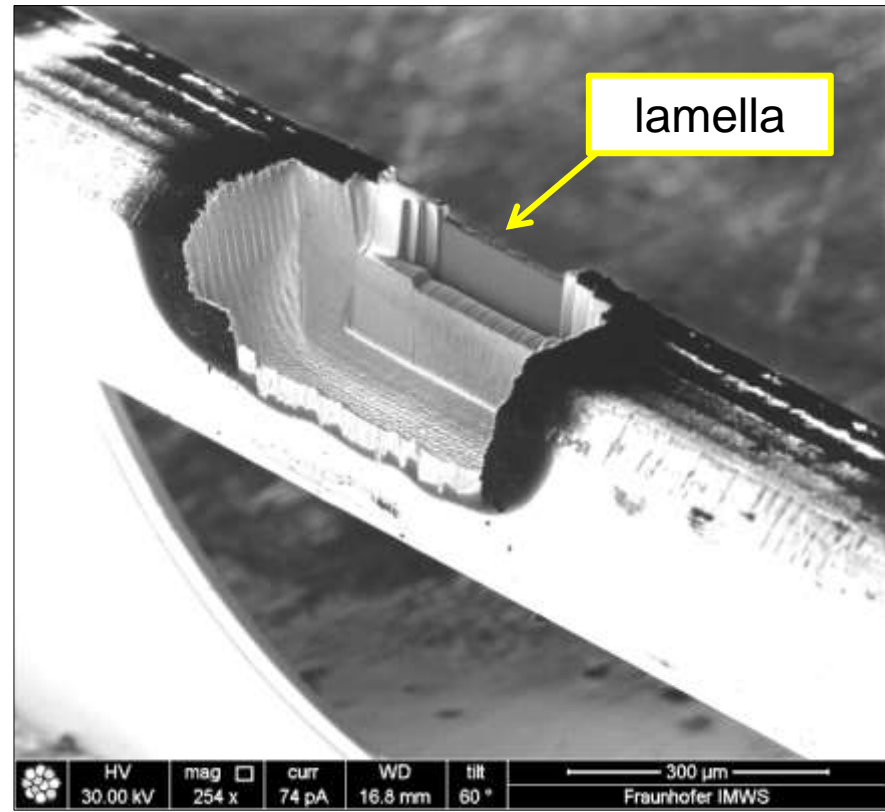
Lamella formation by PFIB

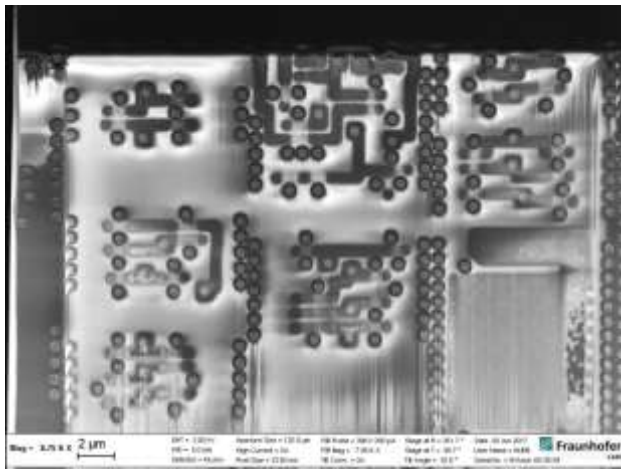
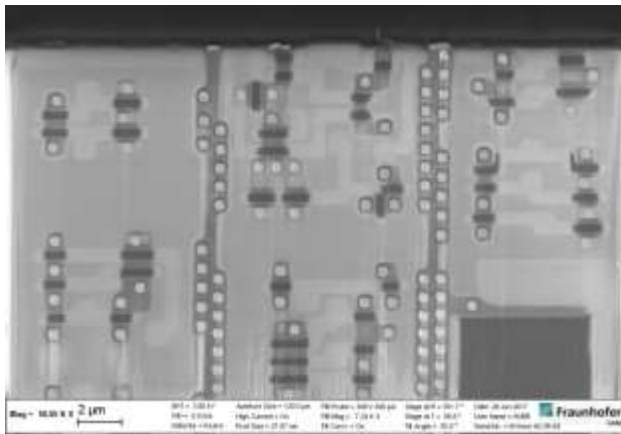
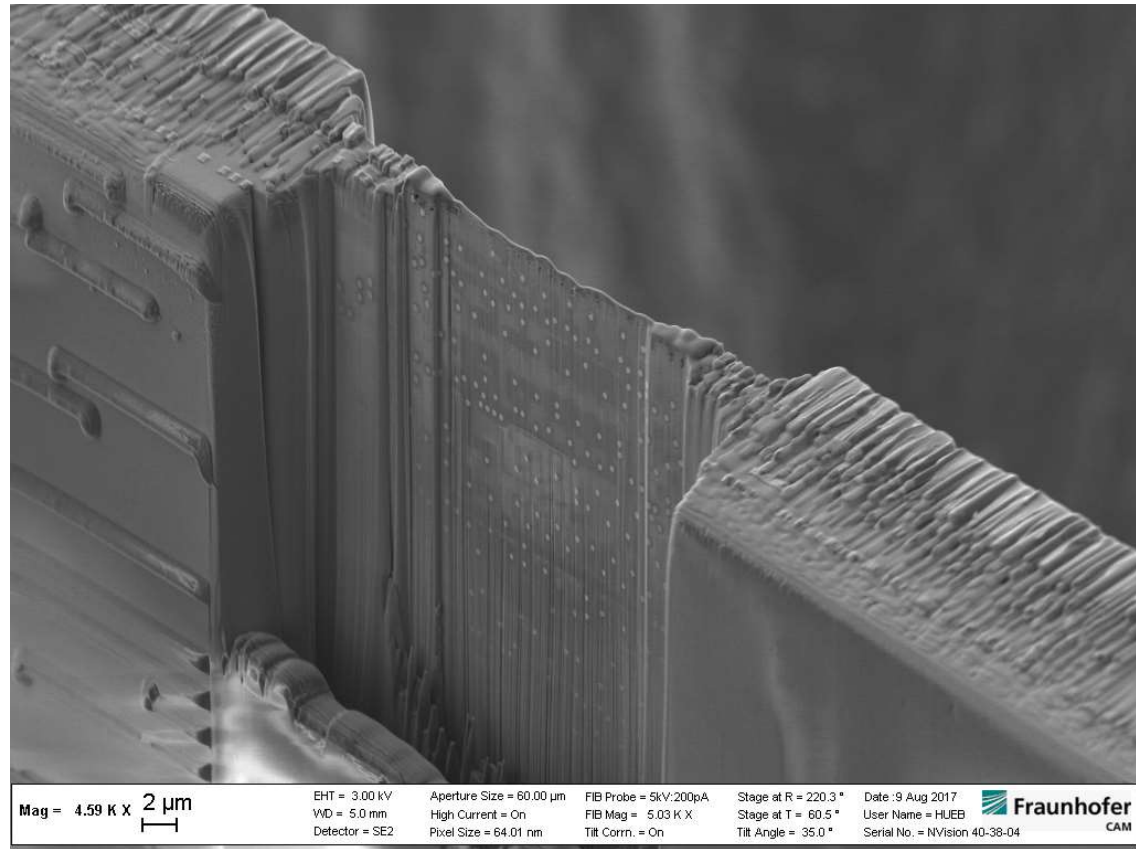
Final TEM lamella

Stepwise removal of metal layers  
in *parallel* to Si substrate

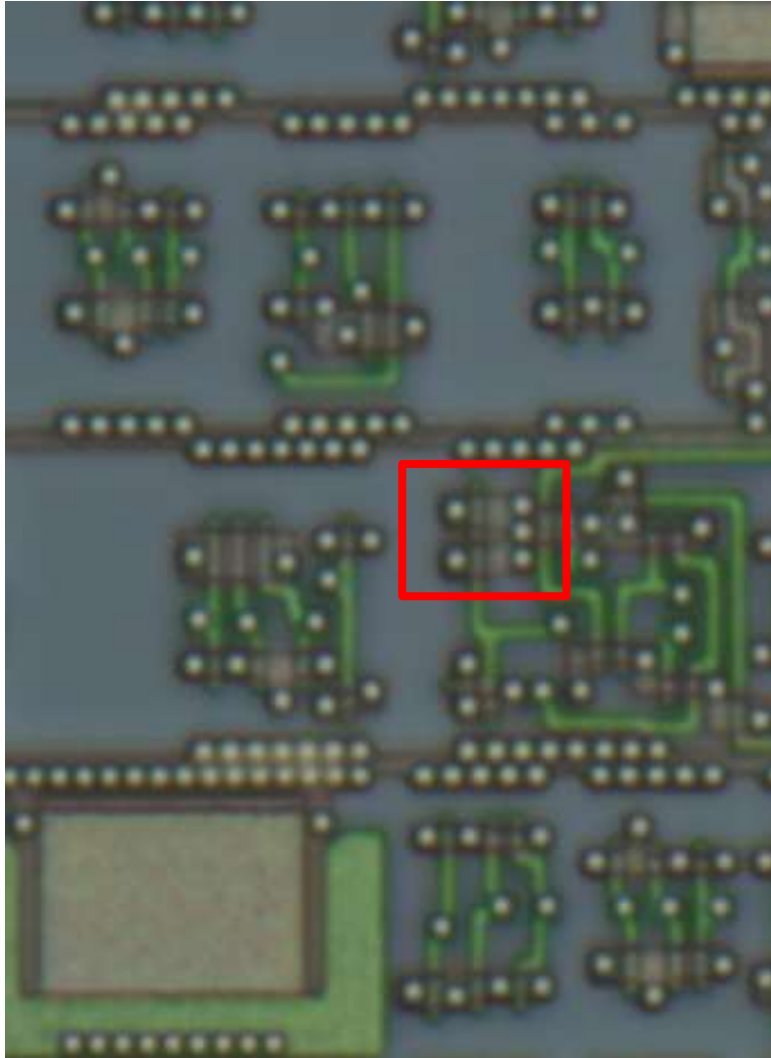
- Low ohmic PMOS transistor with leakage between source and drain
- Shorts via metal lines could be excluded
- dislocation or other defects in Si-Substrate assumed

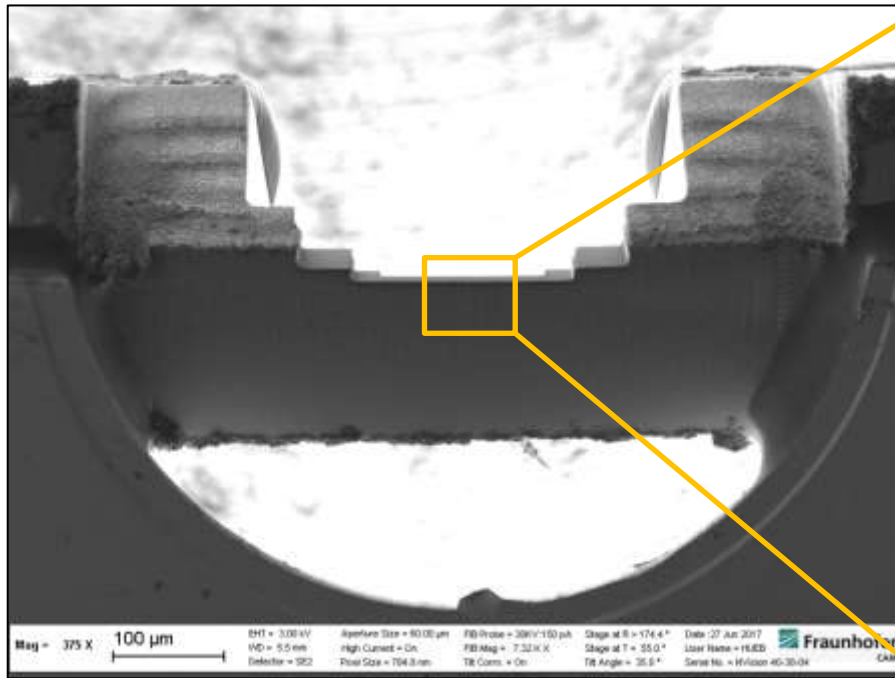
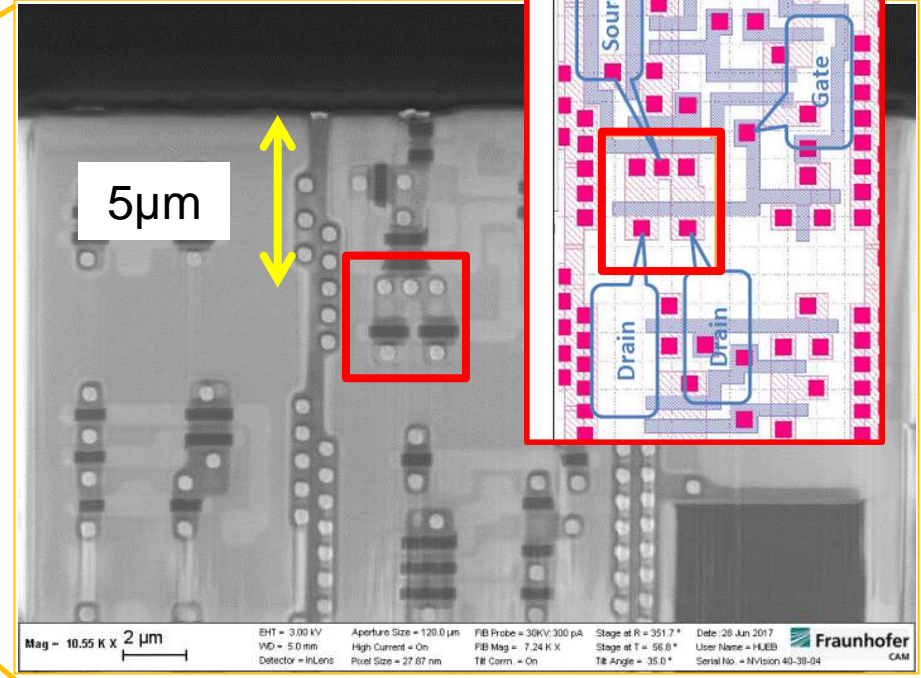
- Laser milling
- Plasma-FIB trimming
- Ga-FIB polishing

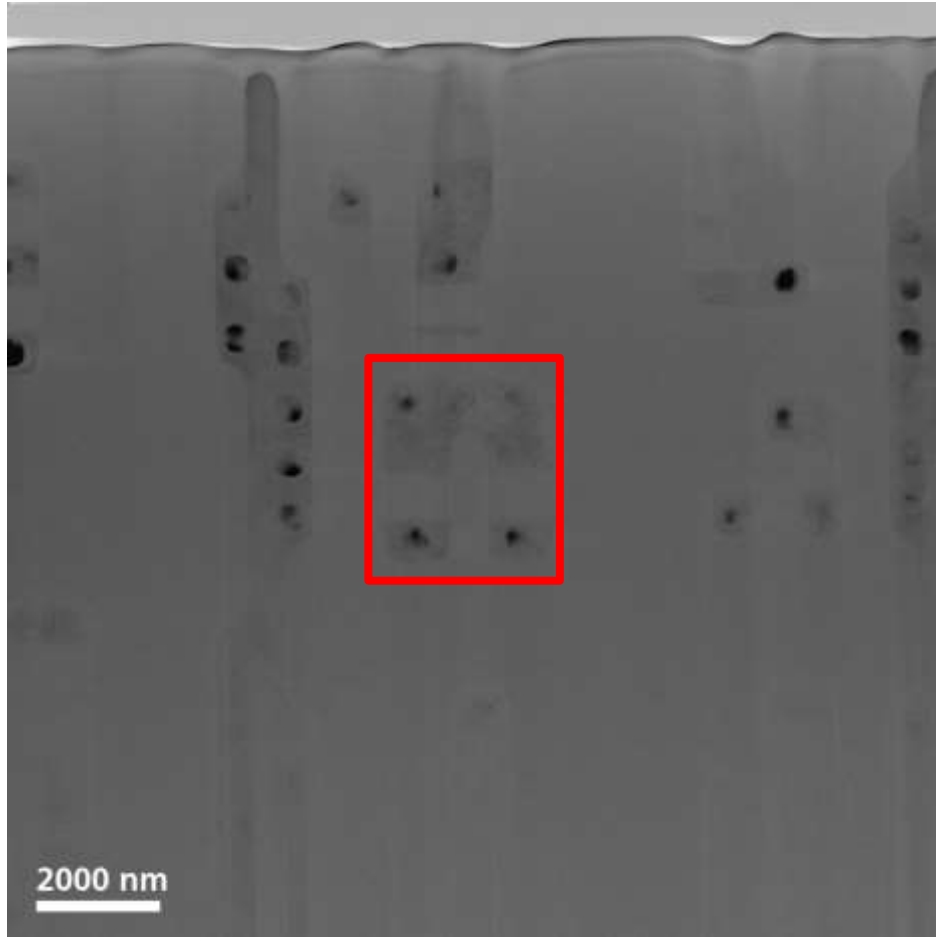
Bright Field TEM image of transistor structure (TEM FEI Titan G2)

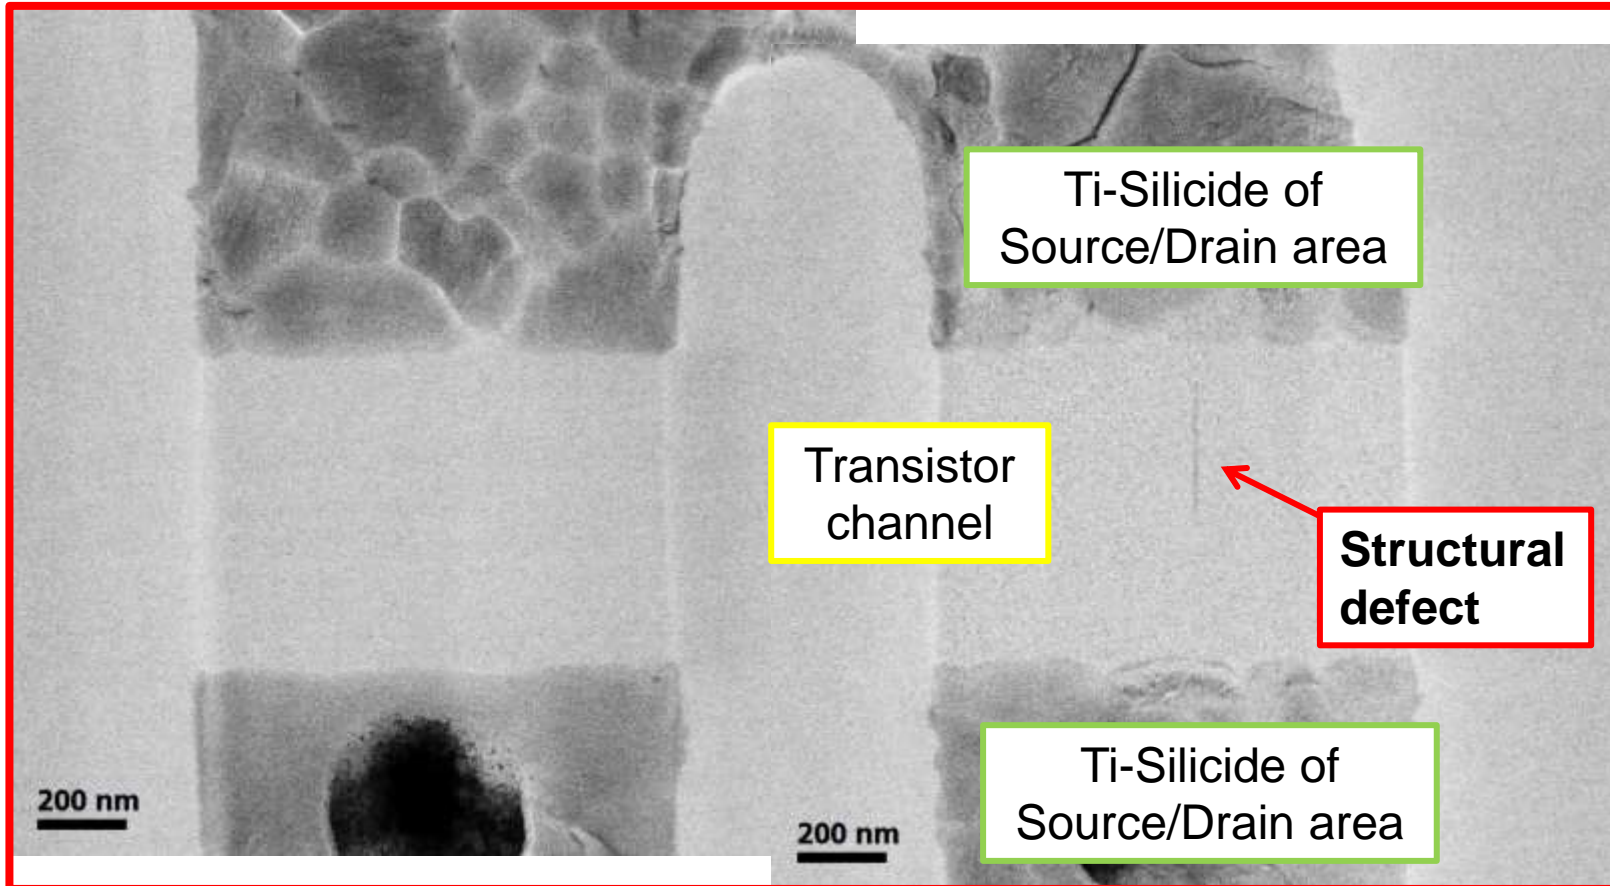
Bright Field TEM image of transistor structure (TEM FEI Titan G2)

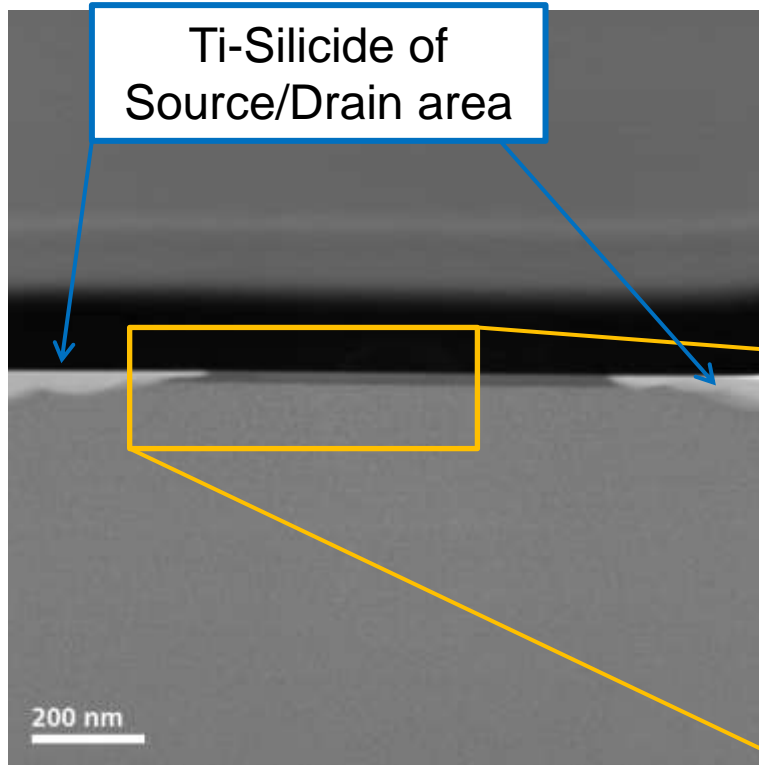
HAADF/STEM imaging

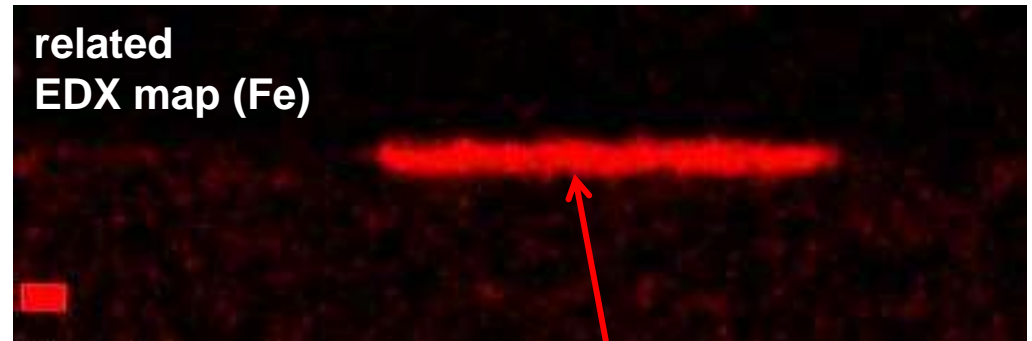
Structural defect at channel surface consist of Fe

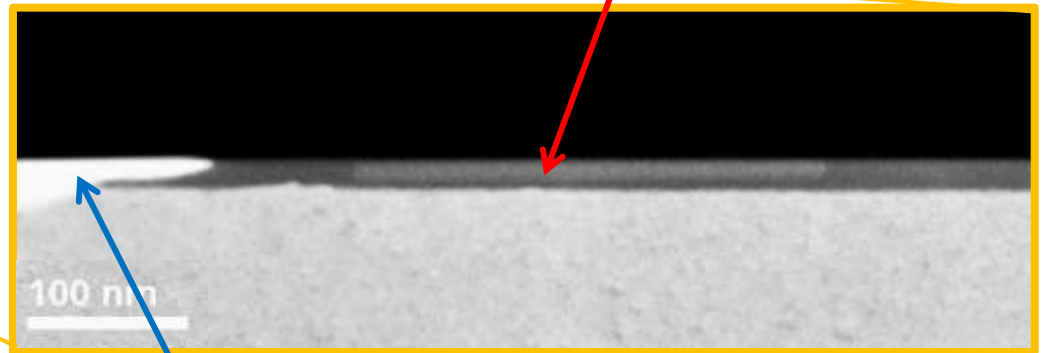
Ti-Silicide of Source/Drain area
