Issues to Be Address for Improved Circuit Edit Productivity

TR Lundquist, T Malik, R Jain, D Renard, VV Makarov

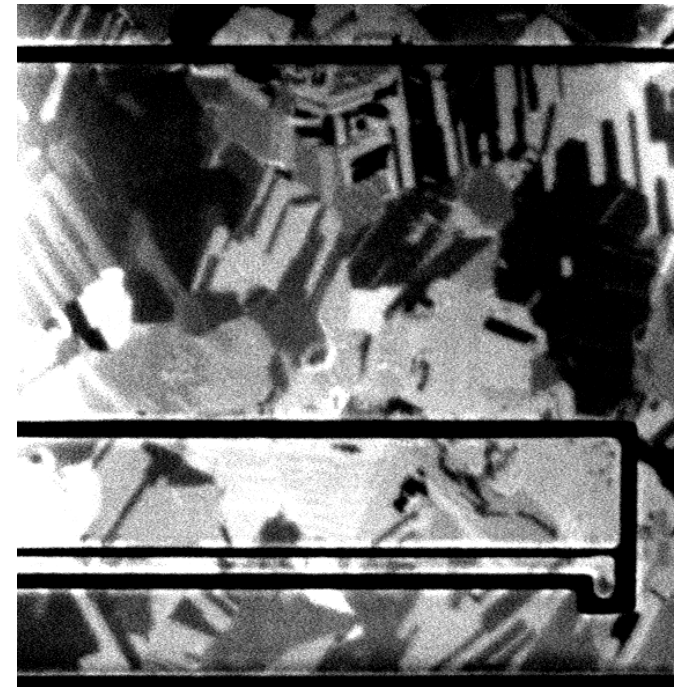
Expose M1 (7 x 7um area) through Cu bus credence

Results:

1. Power plane etched through

- Clean cut—all Cu grains removed
- Dielectric under cut whole—completely intact
- Dielectric under cut was flat

2. M1's evenly exposed

- Underlying dielectric protected
- All Cu traces intact
- All Cu traces isolated

3. Working in a large area improves success rates

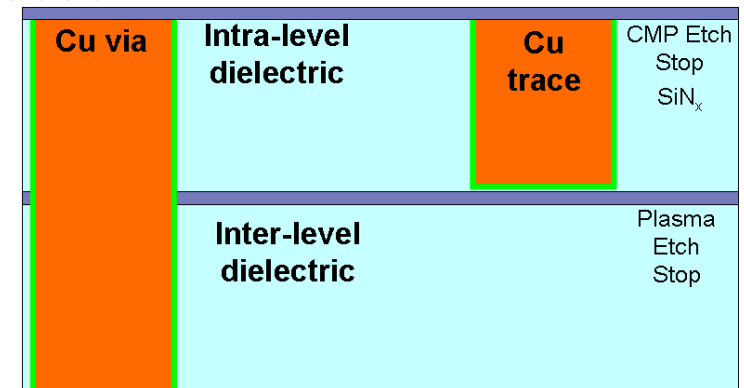
■ Low-k enables thinner dielectrics

- Good news as stack height is less
- Bad news margin for error is greatly reduced
 - Not a low-k issue so much as Cu above
 - Low-k is issue when in Cu planes
 - **Slower process**

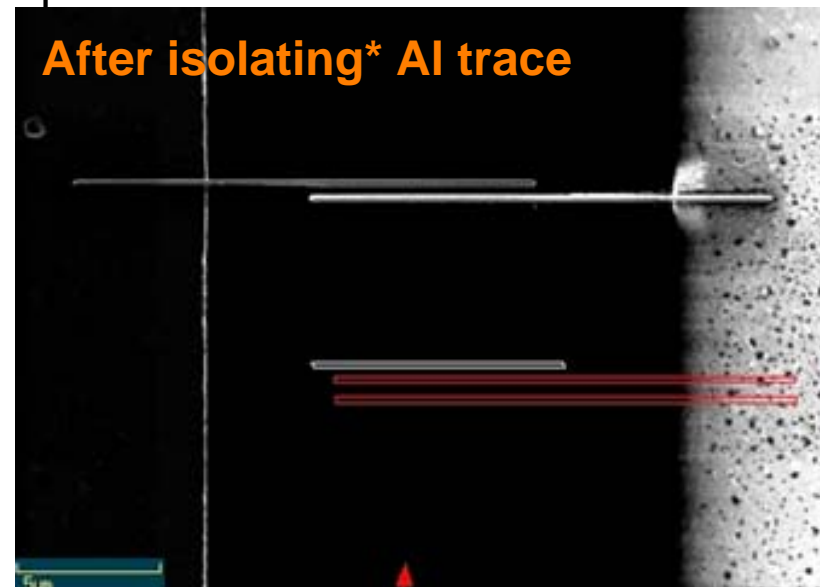
Connect floating M1 trace to adjacent M1 & clean-up

Results:

300 x 200 nm Mo deposit

Re-connection observed

Edit completed without damage to underlying dielectric
